## Photographs 17-18

## Visual Analysis Photographs

Figure No. 11.5

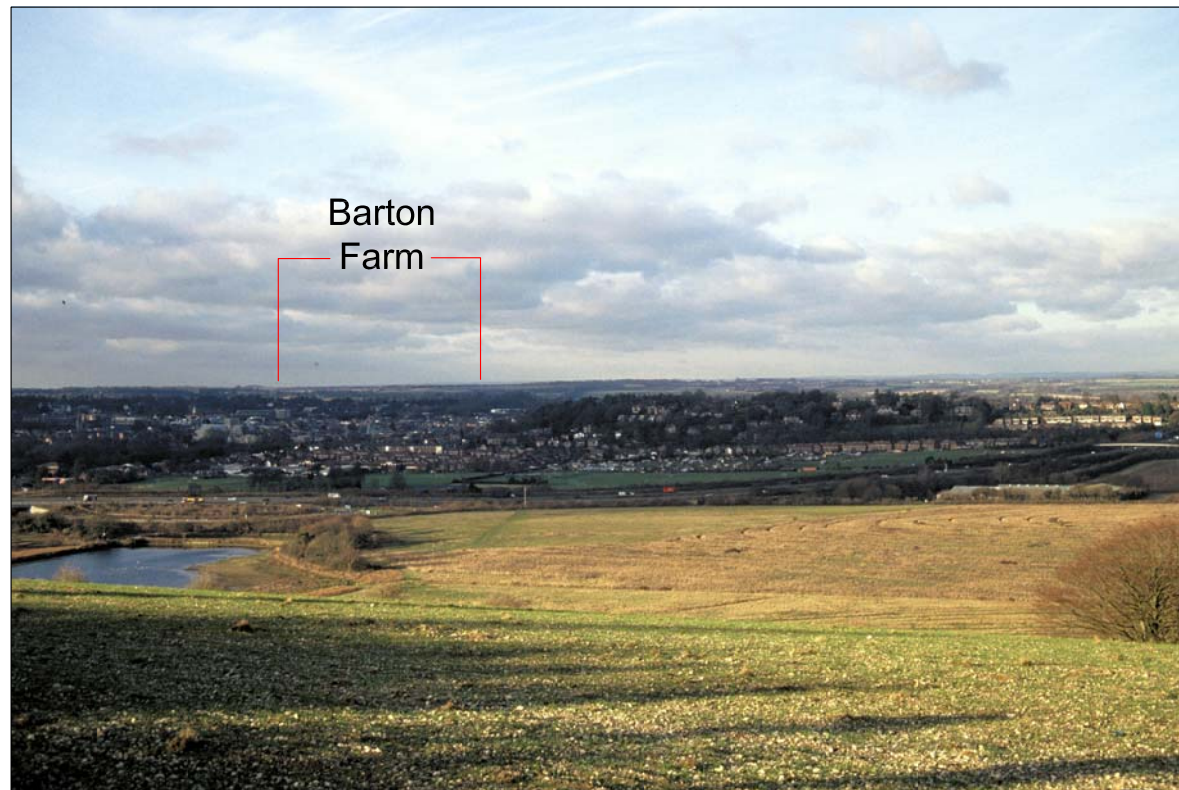
Photograph 17: Looking north-west from Morestead Road near Deacon Hill (elevation of viewpoint 120m). Note steeply falling ground allows clear view over Winchester in direction of Barton Farm. Intervening buildings largely conceal direct view of site. Sewage works visible in middle distance.

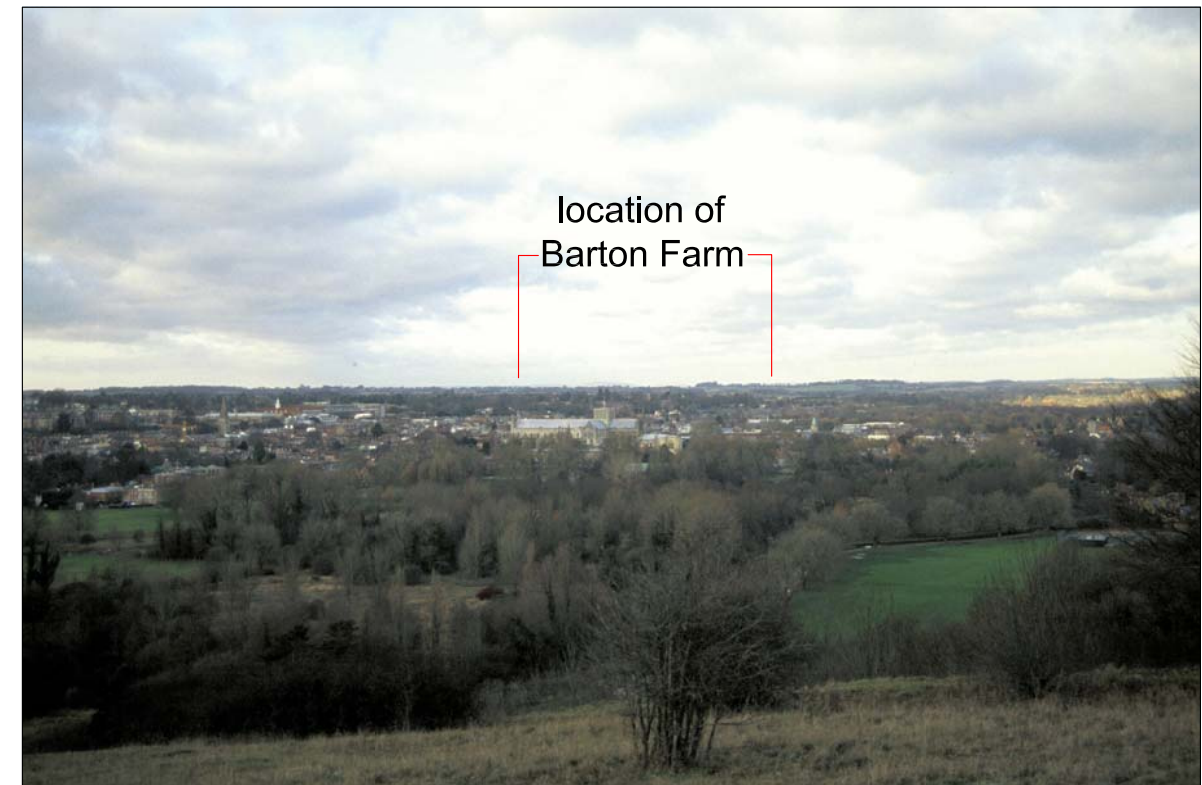
Photograph 18: looking north from summit of St. Catherine's Hill (elevation of viewpoint 93m). Note St Catherine's Hill gives a clear view over Winchester and the downland to the north, but intervening buildings and landform (including the ridge immediately south of Barton Farm) almost completely conceal the site from view.
